# PIPELINE MAINTENANCE

New Jersey Turnpike Authority (NJTA)

PRESENTED TO  
**NJWEA**  
2023 Fall Seminar

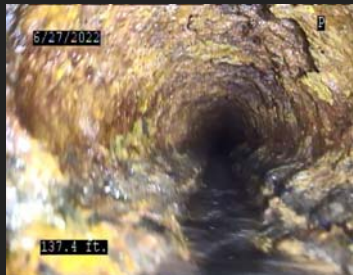
Heavy deposits recorded in this section of CIP sewer main located at about 137'.

Estimated size of existing sewer main reduced to <4"-5" in diameter.

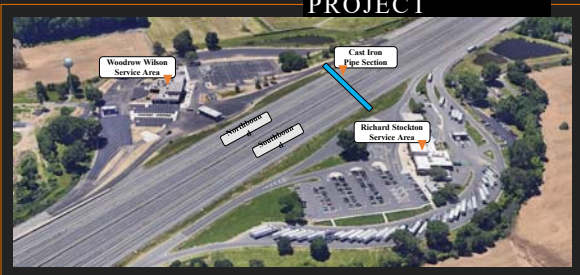
Heavy deposits recorded on the entire section of CIP sewer main.

Estimated size of existing sewer main reduced to approximately <5"-6" in diameter.

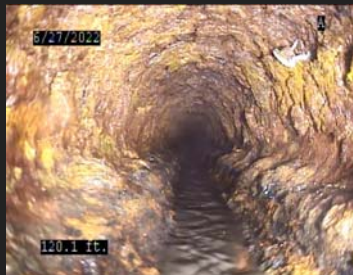
Heavy deposits recorded on this section of CIP sewer main located at about 120'.

Estimated size of existing sewer main reduced to <4"-5" in diameter.

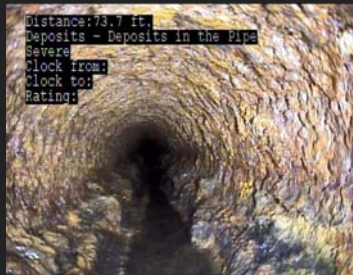
distance: 73.7 ft.  
Deposits - Deposits in the Pipe  
Severe  
Block from:  
Block to:  
Rating:

Severe Deposits recorded at 74 ft inside the CI pipe.

At this point the Camera could not fit into the pipe opening.

Pipe size reduced to <4" opening. End of CCTV.
